Summary

The construction of 12 million social housing units under the Government of India's *Housing for All* by 2022 scheme, presents an opportunity to inform the design, performance and specification of these units, from the experiences of residents inhabiting such developments. As part of the MaS-SHIP project, field study was conducted in five social housing developments across three climatic zones of India. The purpose of the questionnaire survey-based study was to gather subjective feedback from residents about their perception of the overall living conditions related to indoor environmental conditions in their homes, familiarity with the building materials, maintenance, upkeep and access to day-to-day amenities around the development. This document describes the learnings from one of the field surveys of 152 households in a social housing development (Jakkampudi colony), located in the warm-humid climate of Vijayawada (Andhra Pradesh).

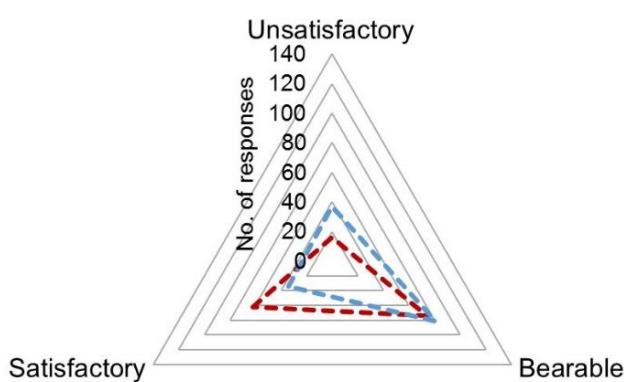
Figure 1: Perceived indoor temperature

Majority of the residents perceived indoor temperature and air quality in their dwellings to be (just) bearable during summer and winter. As compared to the summer period, double the number of households found indoor temperature to be satisfactory in winter, while nearly half the number of households perceived indoor air quality to be stuffy in winter. Although this is likely to be due to the relatively moderate conditions (Avg. temperature-max.= 25 to 30°C, min. = 20 to 25°C, Avg. RH = 75%) in the winter period of Vijayawada, the findings imply the inability of the building envelope to provide comfortable indoor environment (in absence of air-conditioning) in the summer season (Avg. temperature-max.= 30 to 35°C, min. = 25 to 30°C, Avg. RH= 90%) (Figure 1).

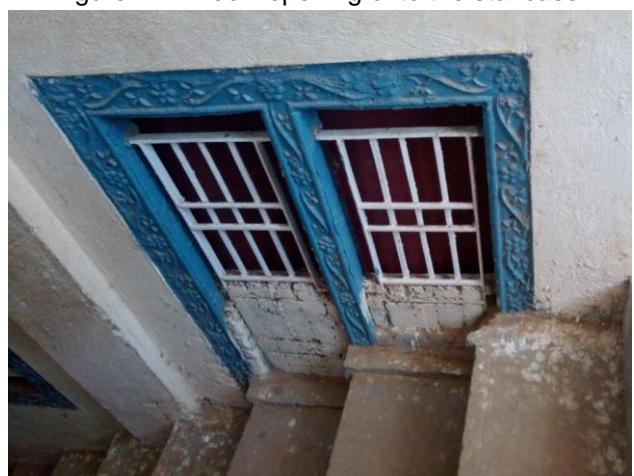
Figure 2: Window opening onto the staircase

Windows are intended to provide adequate daylight and ventilation for maintaining a good indoor environment. However, in the case study development, windows were found to be inappropriately located and designed. Though each dwelling unit had been provided with adequate number of windows and ventilators, the majority of these either opened into the central corridor or the common staircase, making them unusable due to privacy issues (Figure 2). This led to poor levels of daylighting in the dwellings, resulting in electrical lights left on in most of the dwellings during the day.

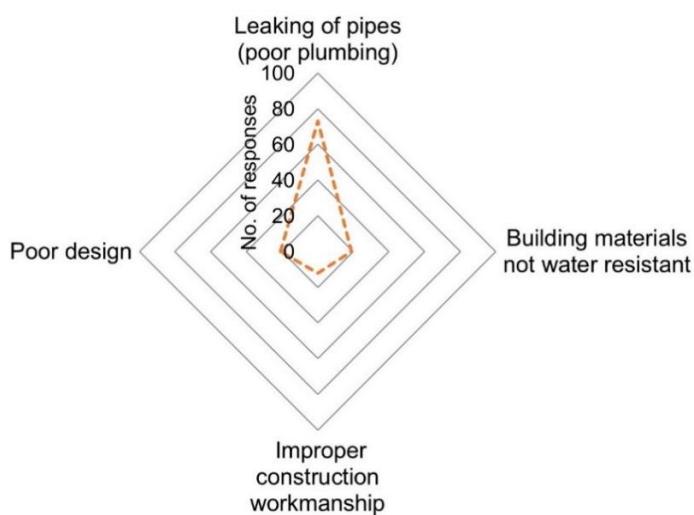
Figure 3: Perceived causes of dampness inside the dwelling

Just after eight to nine years of occupancy, nearly half of the surveyed households reported occurrence of dampness on the toilet and kitchen walls and attributed it to the poor quality of plumbing that led to leaking of pipes, confounded by building materials not being water resistant (Figure 3). Although Building Byelaws require a minimum quality of construction, appropriate site checks need to be put in place by developers and urban local bodies to ensure that construction quality is not compromised. Well-constructed dwellings will tend to be more durable and have lower maintenance costs that are vital for social housing developments, inhabited by Economically Weaker Sections (EWS) or Lower Income Groups (LIG) groups. Good quality of construction and workmanship would also enhance residents' health and safety (in case of natural disasters) and liveability of these developments.

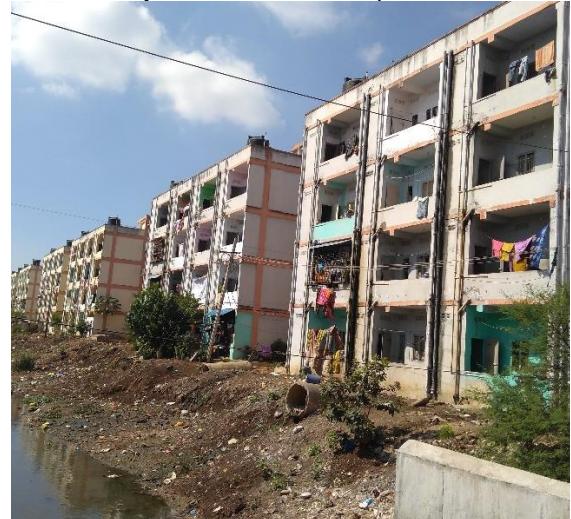
Figure 4: Sewage water accumulated on plot adjacent to the development

Despite having a Residents Welfare Association (RWA) in place, maintenance and cleanliness of the streets and surroundings were poor. The improper planning of drainage and sewage disposal system in the development resulted in the accumulation of sewage water and garbage in the barren land around the colony, leading to hygiene and health issues for the residents (Figure 4). It is evident that simply having an institutional system such as RWA is not enough to keep a clean and healthy environment. Design for maintenance must be incorporated at the planning stage of a social housing project, through provision of appropriate infrastructural and institutional arrangements, to ensure sustainable disposal of different forms of waste that are generated in the development.
